An Applied Geophysical Detection and Subsequent Mitigation of an Abandoned Well Casing Penetrating the Permian Hutchinson Salt at an Undisclosed Kansas Salt Mine

AN APPLIED GEOPHYSICAL DETECTION AND SUBSEQUENT MITIGATION OF AN ABANDONED WELL CASING PENETRATING THE PERMIAN HUTCHINSON SALT AT AN UNDISCLOSED KANSAS SALT MINE

A surface field survey, using a cesium magnetometer, successfully targeted the spatial location of an abandoned buried well casing. Surface excavation exposed the top of the well casing, but attempts to drill out the casing from the surface failed due to the difficulty of keeping the drill bit on-line with the casing. The casing was successfully sealed off by grouting through the ceiling and floor from within the mine.

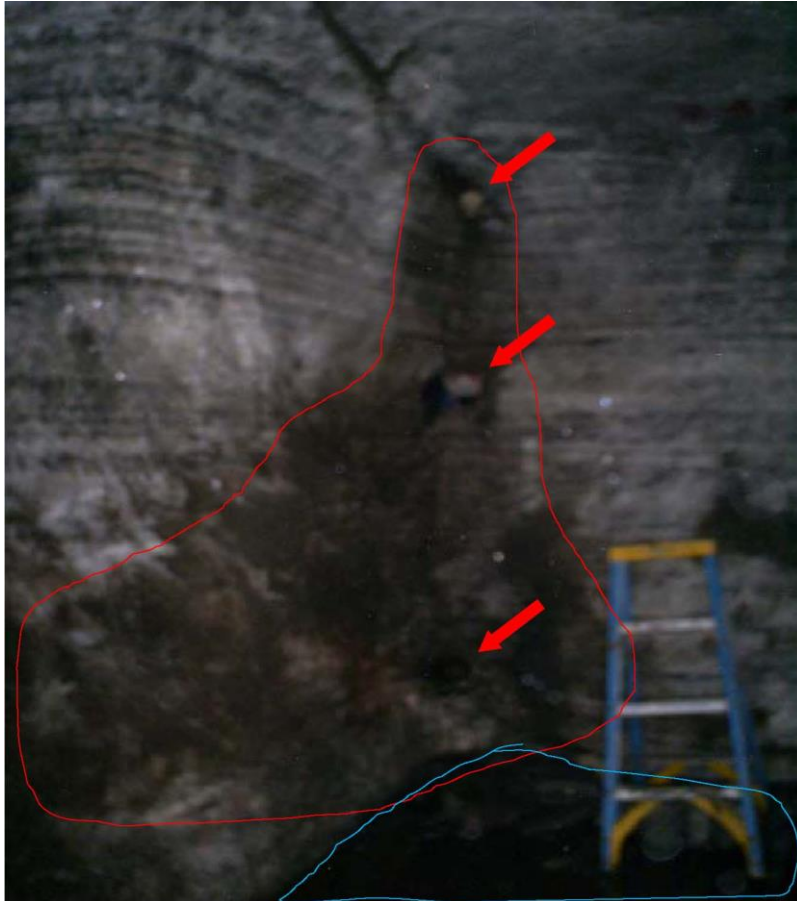
as it was located about one meter into the solid working face at the end of a side-cut, just off to the side of the main drift +heading. Instead, it was discovered when trapped water which had developed head pressure burst out through three “boot holes” that pierced into the well bore cavity during normal salt blasting involved in the mining process. No one was present when this occurred, as the miners evacuate just prior to blasting at the end of each shift. The evidence of the sudden burst of water appeared sometime after the blast, as an

unusual mark left behind on the wall or “rib”, as miners commonly call it, where the water had sprayed out and deposited bits of shale and debris from the old well (fig. 1). The

Figure 1. Red arrows indicate where the blast “boot holes” which intersected the abandoned well are located. The thin red line outlines the area along the “rib” affected by the water/mud spray following the blast that exposed the abandon well bore. The blue line outlines standing water left on the floor. The ladder is 1.5 meters’ high.

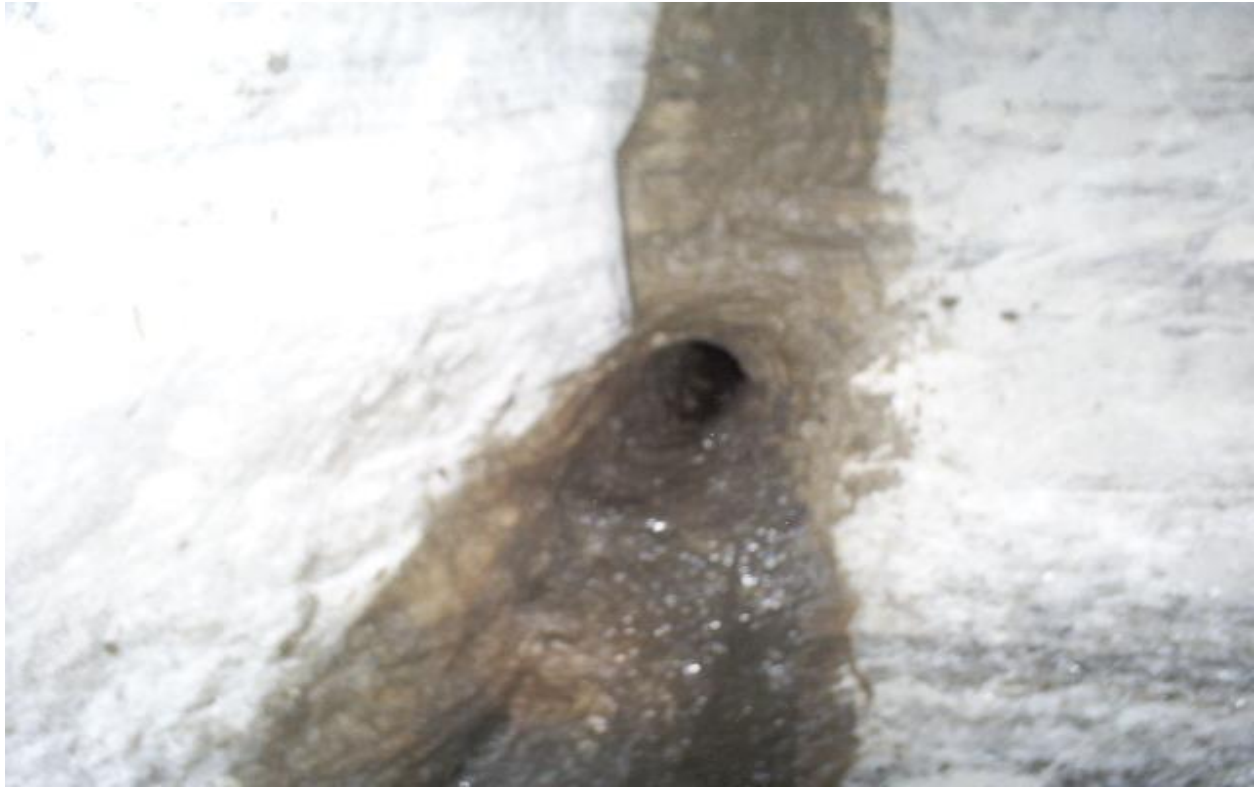
During the first few days after the incident, water began to trickle from these “boot holes” (fig. 2). After a few weeks, the underground mine manager was able to collect the water in buckets and was able to estimate water inflow rate at 7-10 GPH (Gallons Per Hour). Over the course of the next few months, that rate eventually increased to as much as 22 GPH. The leaking water was tested with a Salometer and the salt-saturation

level was found to be near 100%.

Figure 2. Water flowing from one of the three “boot holes”.

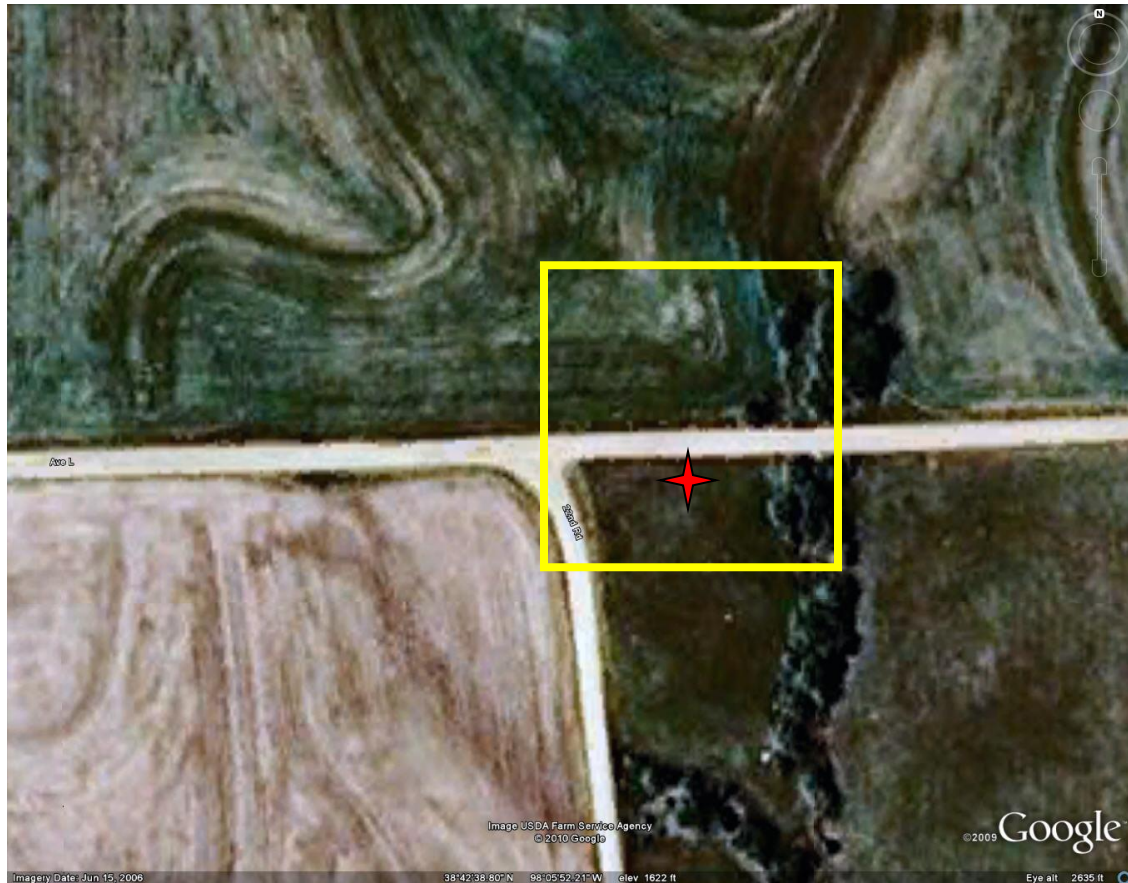
Figure 4. Goggle Earth image of survey area 80m x 80m in yellow. Red star targets location of well casing.

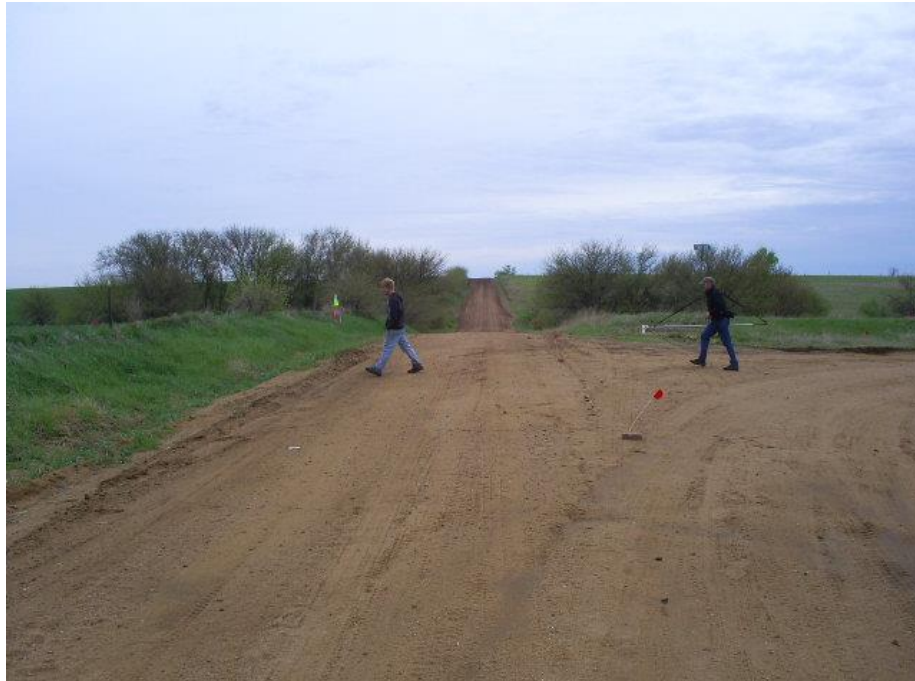
Figure 5. View east with study area Well casing target located approximately 5 meters due east of Mr. Jeff Lawler (right, carrying the magnetometer unit) who is walking northward and parallel to the field grid

An 80 meter by 80 meter grid with 10 meter N-S and E-W field spacing was established over a potential surface locality inferred or projected upward from the underground mine. Four separate surveys over the same grid were conducted to assure at least one quality run. All four provided the same usable data. A cesium vapor G-858 unit (Geometrics) was used for the survey. Techniques employed to locate the well head followed those proffered by Breiner (1973), Frischknecht, *et al.* (1983), Rivers (1995), and Jordan and Hare (2002). Data were downloaded using Geometrics MapMapper

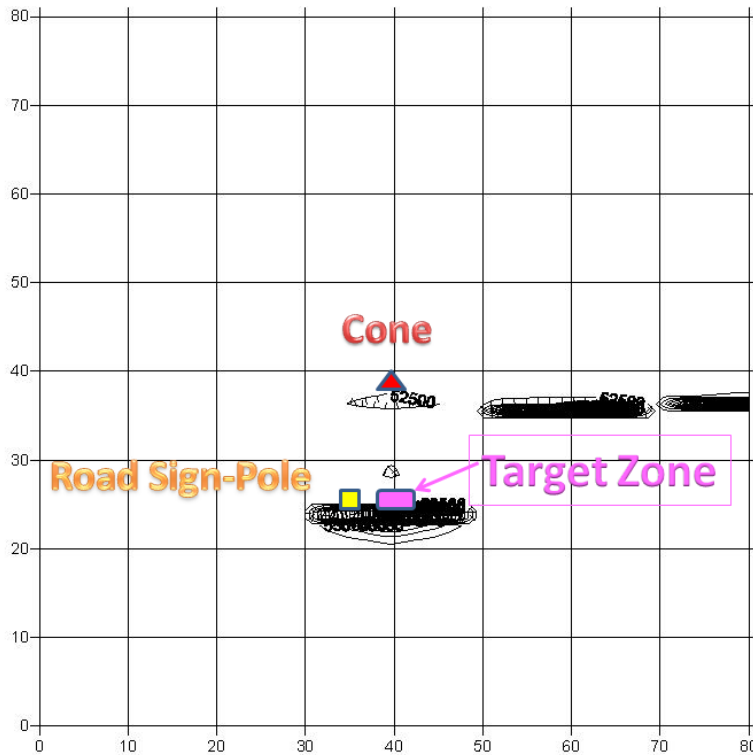
The results of magnetometer survey were successful in targeting the spatial position of the buried metal object. Half-slope depth calculations (Peters, 1949) indicated a depth range to the top of the well casing of 0.2-1.5 meters below the surface of the ground (figures 4-7).

Figure 6. North to towards top of figure. Magnetic anomaly map and targeted suspect well casing. Grid in meters. Red line = North-South profile line through anomaly. Golden Software Surfer 8.0 2004 Golden, Colorado.

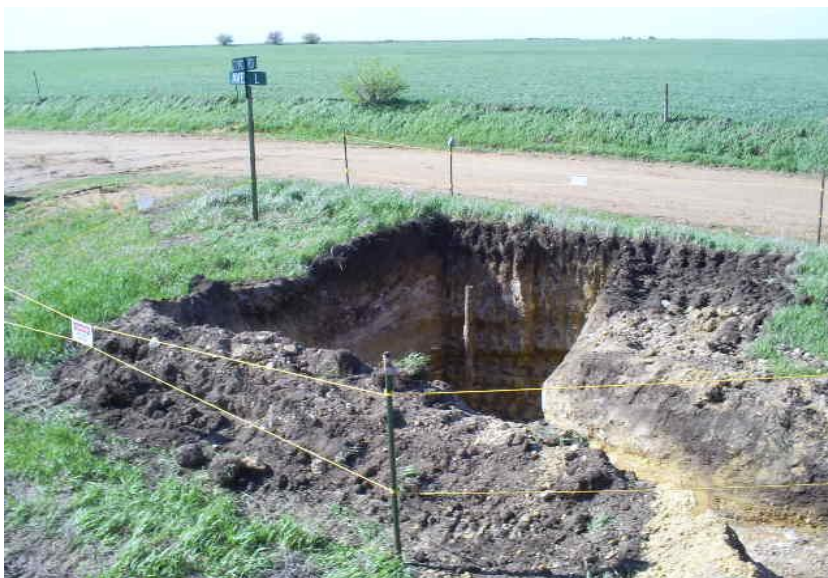
Figure 8 Exposed abandoned well casing located 0.6 meters below ground level. View Southwest

Once the abandon well casing was located and exposed with a backhoe and shovels (fig. 8), the consulting firm devised a plan to “overdrill” the old casing in an

Unfortunately, attempts to “over drill” and completely remove the old rusted casing

failed. The drillers managed to over drill and remove approximately 33 meters of the casing before slipping off to one side and drilling an additional 20 meters, unaware they had diverged from the original alignment. This was largely caused by the fact that the original well deviated more than 16 meters from vertical as confirmed by the surveyors. Once the drilling deviation was discovered, mine management decided that it was not desirable to continue drilling on the misaligned hole as it would not accomplish the original goal of removing the old casing and it was feared they would end up with two holes into the underground workings rather than one. Drilling operations were abandoned shortly thereafter.

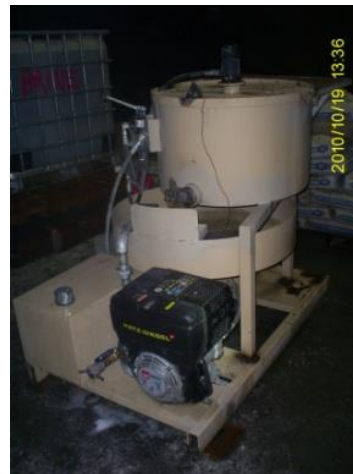
Figure 9. Diesel powered grout pump.

remote underground site in dry sacks. It was ultimately decided that a mix which utilized brine water and had good sulfate resistance be used. However, this proved to be challenging because of the remote location of the job site in the underground mine. Cements with good sulfate resistance were not available in bags, only in bulk, thus mine officials designed a mix utilizing Portland Type I/II Cement which is the most common type in bags. The mix was comprised of a cement/fly-ash/brine mix in the following quantities: Two 42 kilogram sacks of Type I/II Portland Cement, one (1) 32 kilogram sack of Type F Fly Ash (for sulfate resistance), mixed with 60 liters of 100% saturated brine. This mix worked well, as it volumetrically fit into the hopper of the diesel powered grout mixer/pump (fig. 9).

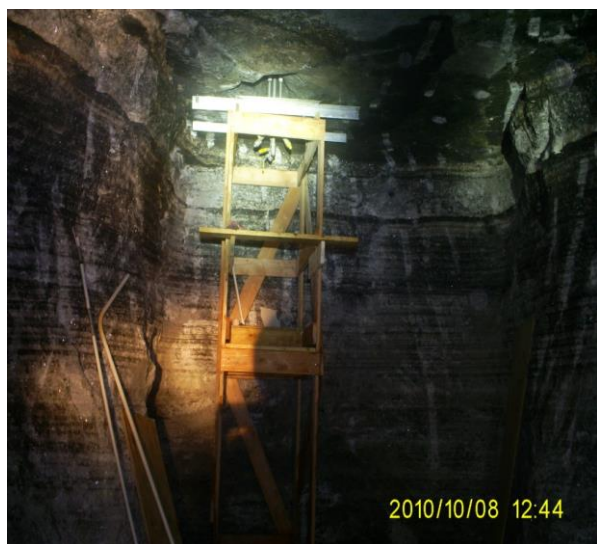
Figure 10. Wooden structure with aluminum plate to hold riser pipes.

discussed but it would not easily accommodate the specific conditions. Instead, a wooden structure (fig. 10) was chosen as the work platform. It was custom built at the site to support a specially designed aluminum plate which held the five individual grout riser pipes in place. A multi-level work deck was installed approximately 2 meters below the mine roof for access to install and utilize the pipes and valves above for grouting operations.

The riser pipe elevations (above the mine roof) were set at 0.6, 3.4, 9.1, 21, and 30.5 meters. These elevations were chosen using volumetric estimates derived from photos and videos taken from inside the well bore from the mine level. The elevations and stages were designed to accommodate the working time of the grout and to maximize the volume filled with each stage of pumping. Grout was pumped from each lowest open pipe to the next highest pipe during each stage of the process, progressively moving higher each time. A valve on each of the lowest pipes,

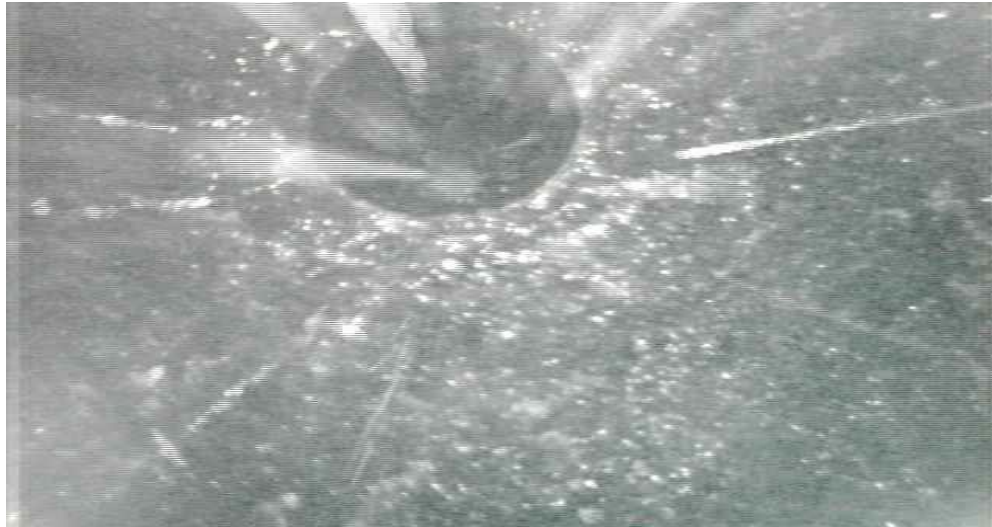
The initial goal was to try and reach the top of the salt formation with the grout. However, because of the volumes needed, the remote underground location, and the size restrictions on available equipment, this was no longer a reasonably achievable goal. Based on photos and videos, we knew the hole was not uniform in shape or size but in fact varied widely in diameter through at least the zone we were able to see, as dissolution affected different layers depending on salt and shale content (fig. 11).

Photos from the borehole camera show the 15 cm diameter hole through several of many zones of less soluble material. At first glance, these narrow zones with the original diameter intact may appear to be the end of a pipe. However, after penetrating several of these zones with the camera, it became apparent why the diameter was changing so drastically. Zones of shale, gypsum, and sandstone, likely kept the original diameter intact as they were much less soluble than adjacent salt layers. Knowing the original

diameter was 15 cm, it was relatively easy to estimate the diameter of the areas enlarged by dissolution as shown in the photo. This

Figure 11. Borehole camera view up to base of shows the 15 cm diameter hole.

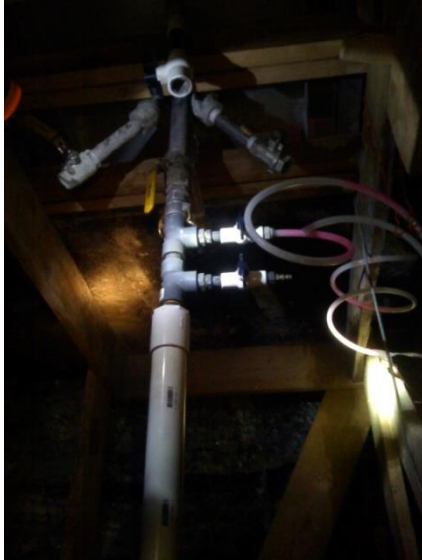
Figure 12. Air manifold for the pressure/volume test.

Mine officials decided that it would be beneficial to know the volume of the remaining void above the 30.5 meter elevation for future grouting operations if necessary. To determine this, a known quantity of pressurized air was released into the void using a special manifold attached to the 30.5 meter riser (fig. 12). The air pressure was allowed to equalize between the void and the attached air tank. A water gauge attached to the manifold was read and the resulting pressure was used to determine the volume utilizing Boyle's Law. The height of the remaining void was still unknown but was estimated to be approximately 23 meter based on average salt thicknesses in the area. Using this estimated height as a base, the average diameter for that portion of the hole was calculated. The air pressure test was conducted four times and the average volume

of the void was determined to be 46 cubic meters. This is almost 7 times the volume of the lower portion of the well as it passes through the salt formation to the mine level.

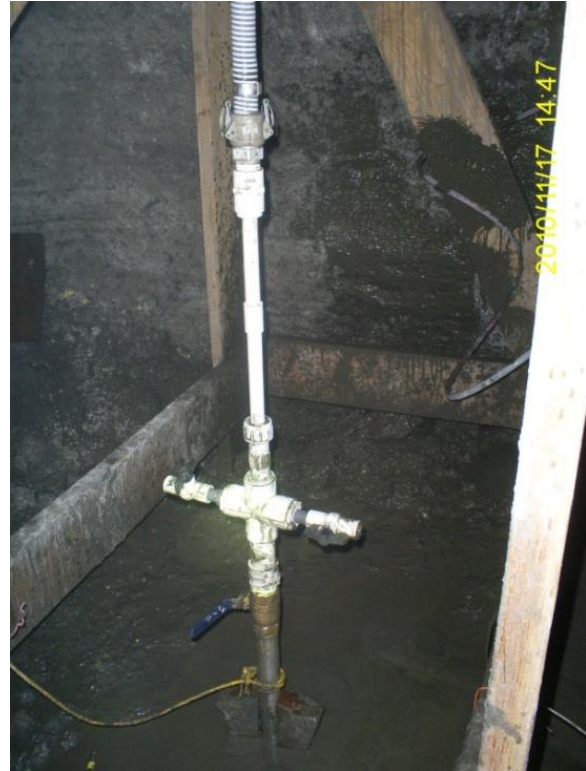
Figure 14. Miniature “Blow Out Preventer” on lower hole.

Upon the completion of the upper grout plug, focus was shifted to the remaining open hole in the mine floor. The depth of the hole was measured and known to be at least 6 meters below the mine floor. Attempts to open it deeper were made but largely unsuccessful. To plug the hole, a 6 meter section of 3.2 cm 316SS pipe was installed 6 meters down the hole and grouted in place to act as a packer. Once the grout had set around the pipe, the section of the hole below the lower end of the pipe was flushed through a miniature “Blow-

Out-Preventer” (fig. 14). This was done to ensure that any trapped or dissolved gasses that might be present in the water could be contained and controlled.
